ASTM E1886 and ASTM E1996 TEST REPORT

Report No.: E8391.02-301-44

FLEETWOOD WINDOWS AND DOORS
Corona, California

PRODUCT TYPE: Sliding Door
SERIES/MODEL: 3070-HI

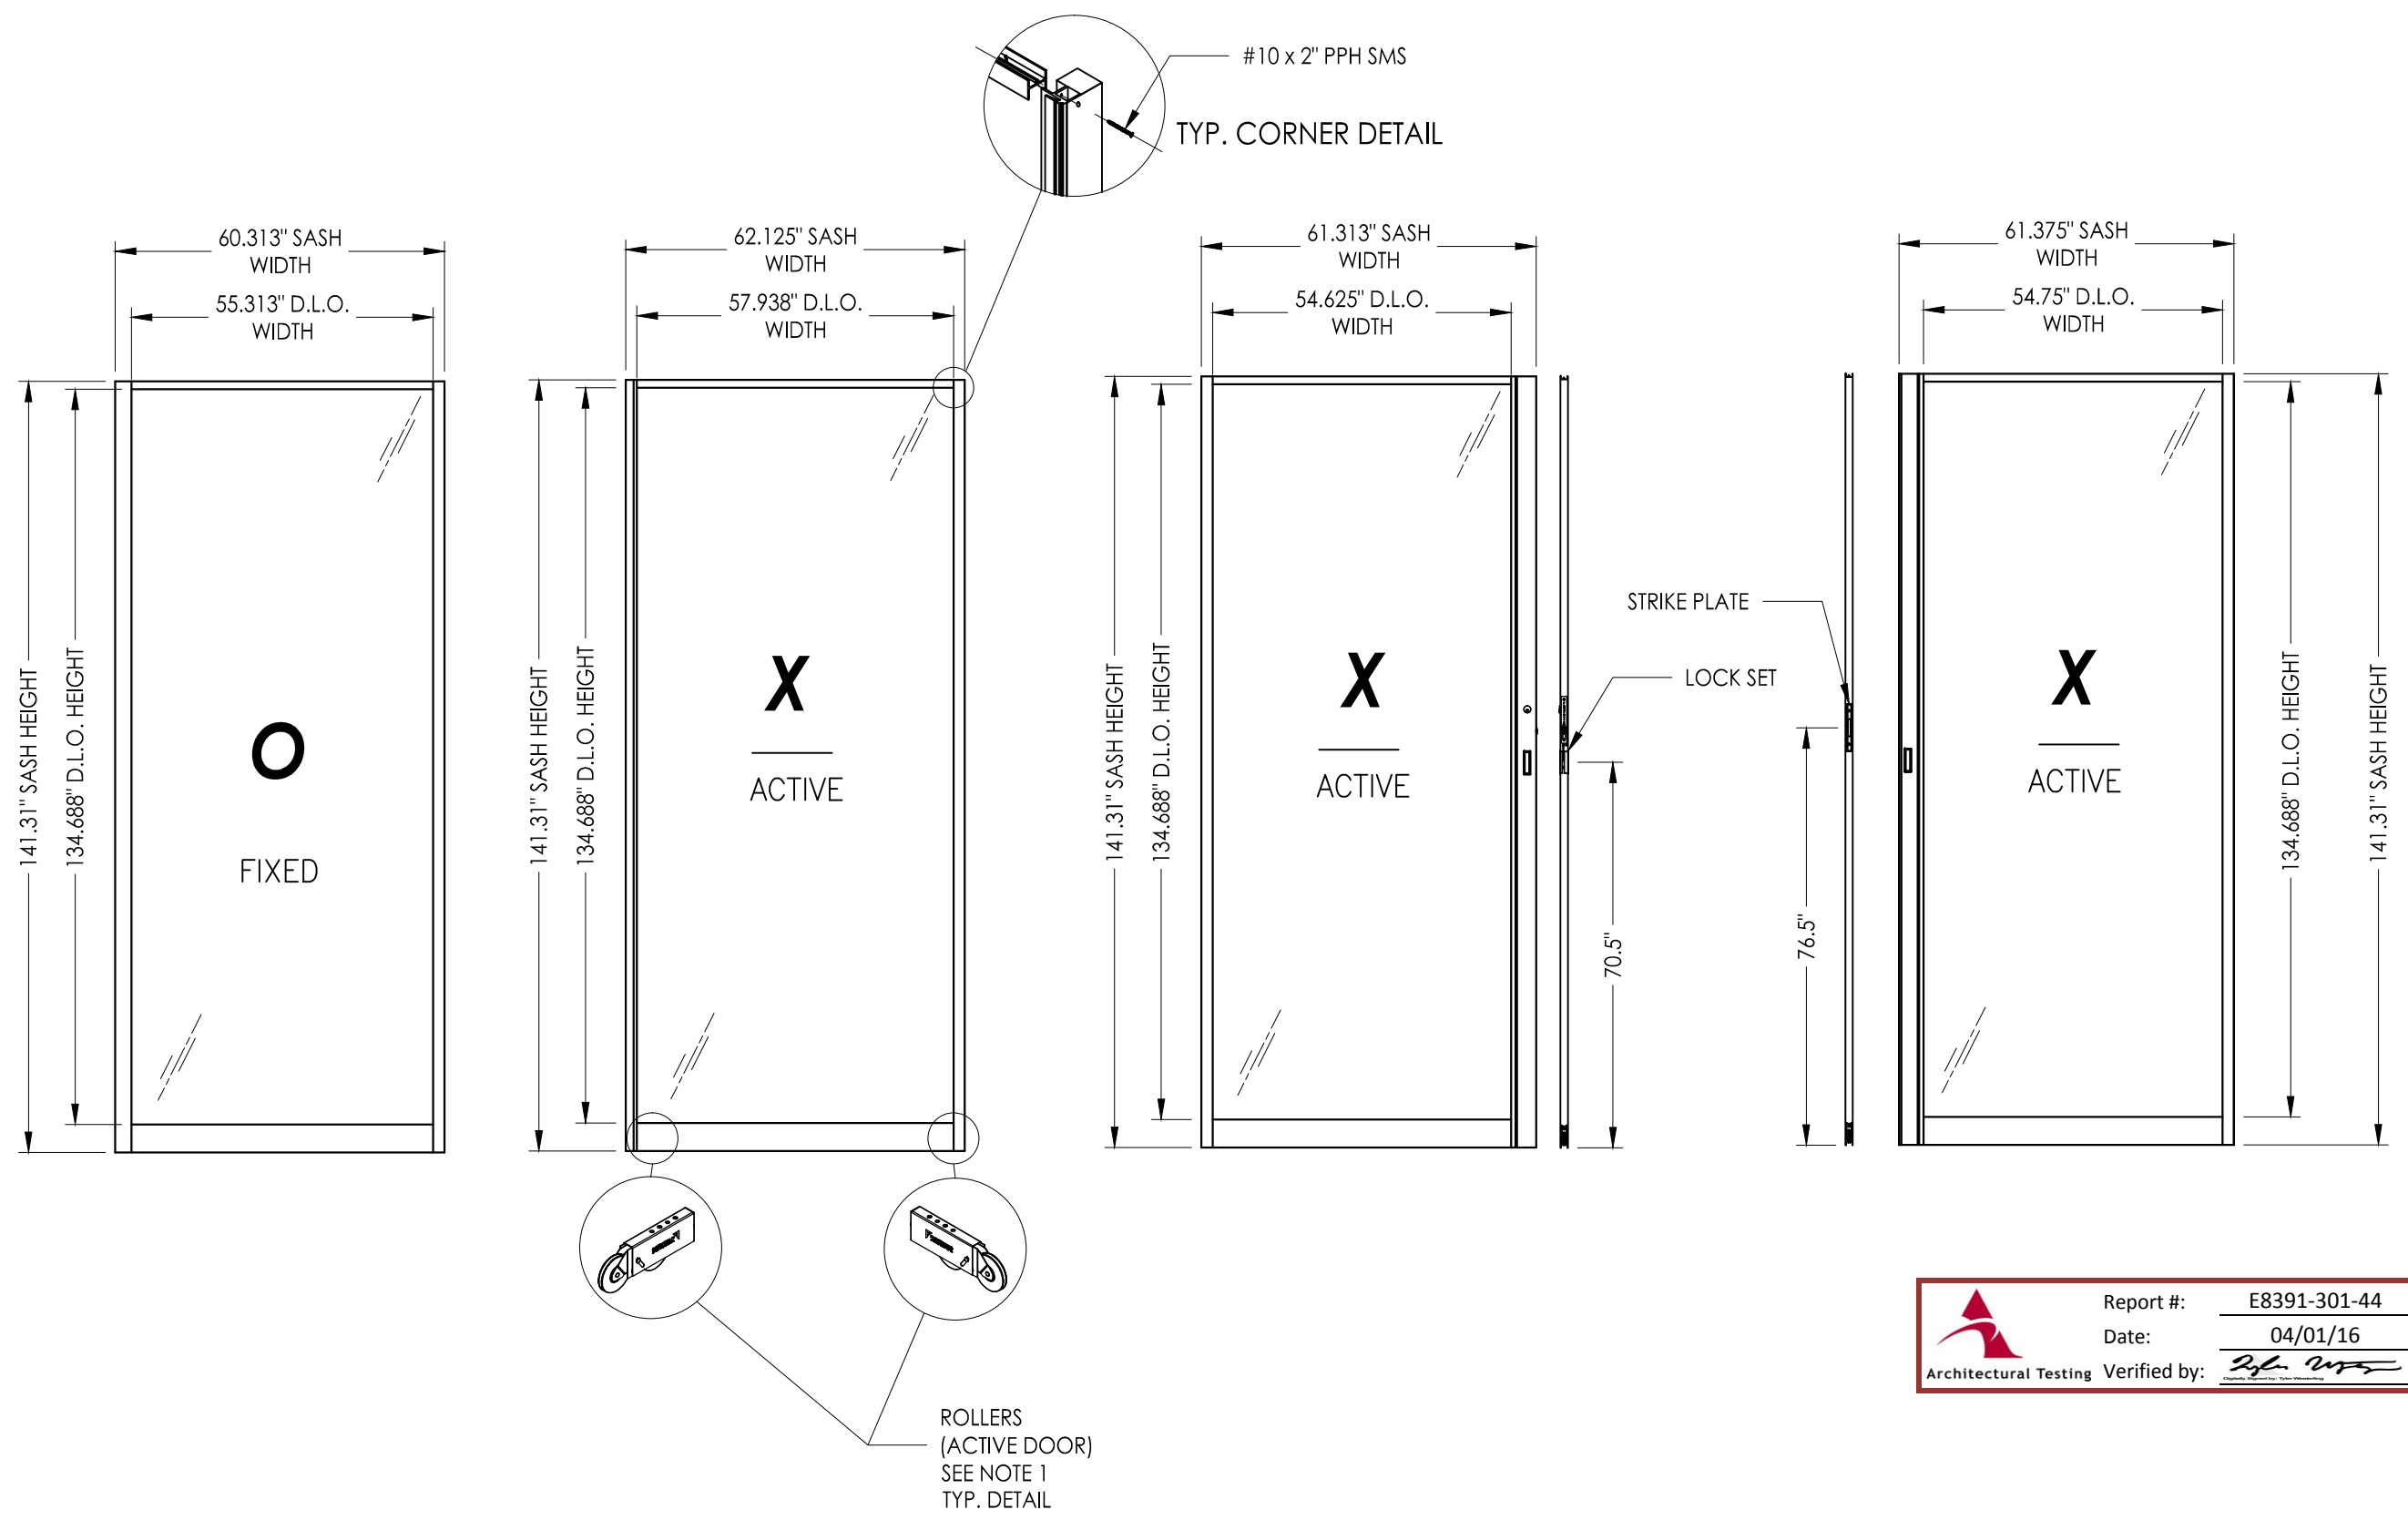
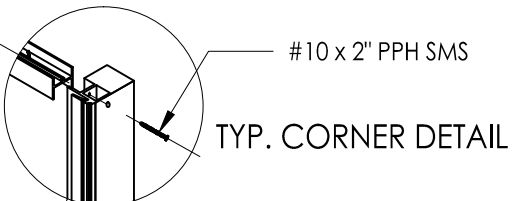
ROLLERS
(ACTIVE DOOR)
SEE NOTE 1
TYP. DETAIL

Note:
1. Roller attached to bottom rail utilizing (2) 1/4-20 x 1/2\"/>

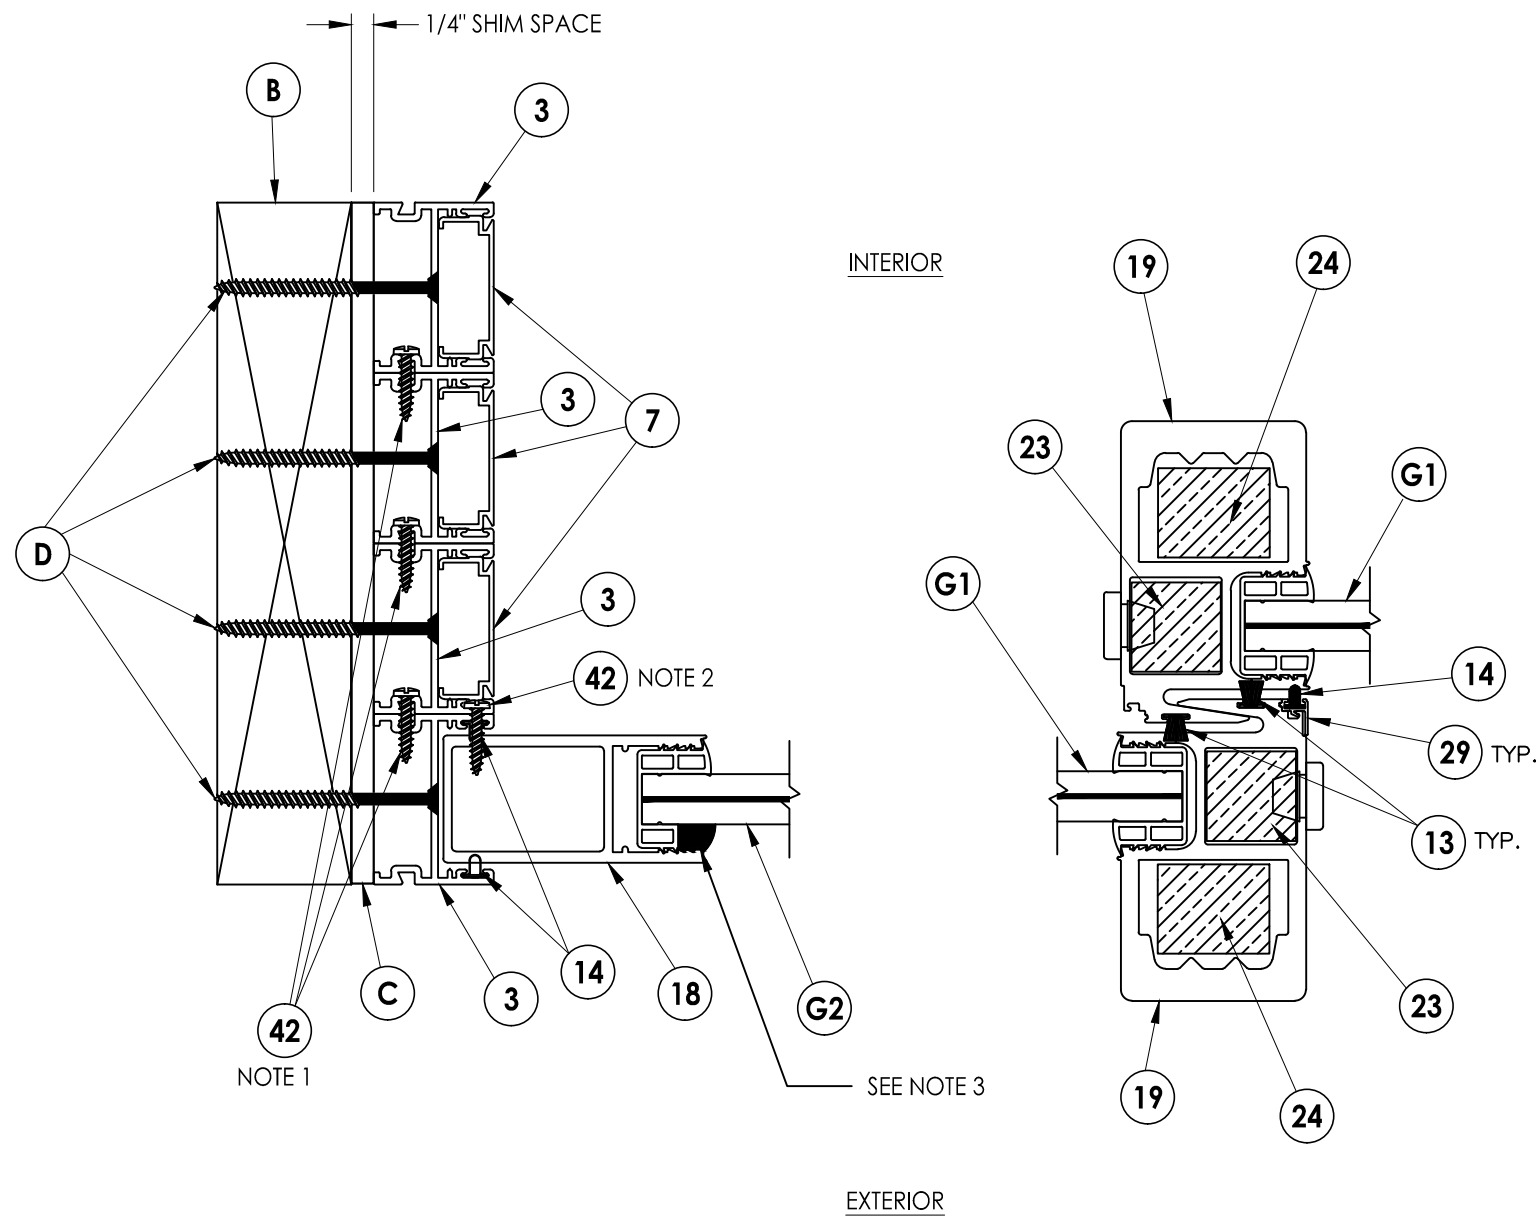
1
3 HORIZONTAL CROSS SECTION

- NOTE:
1. 1" from each end then 60" on center.
 2. 48" from each end (2) total
 3. Interior or exterior (gasket cut 2" from top rail and bottom rail on stile).

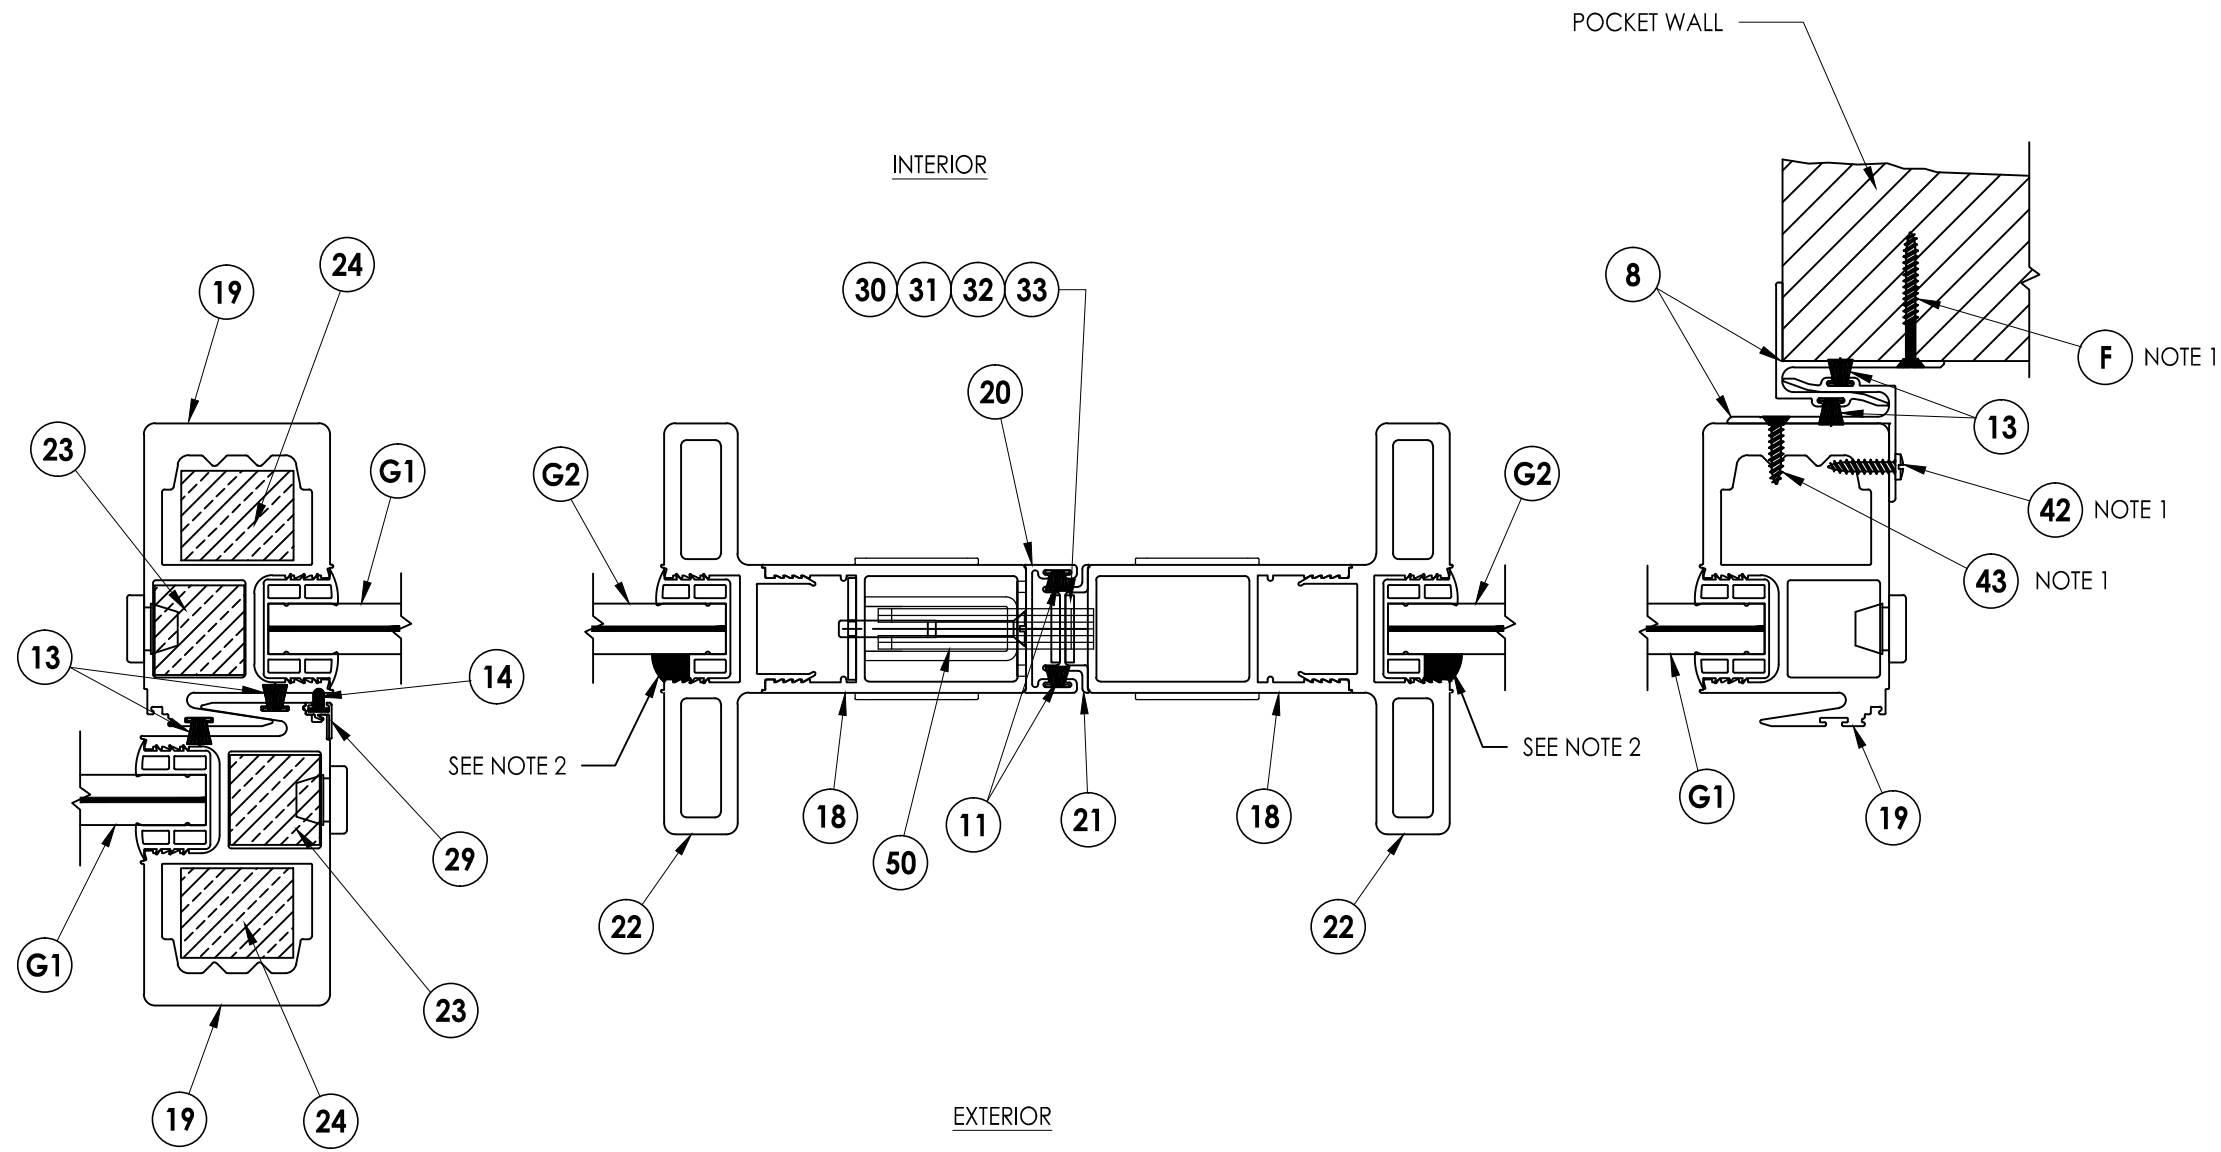
1
4 HORIZONTAL CROSS SECTION

NOTE:
 1. 2" from each end then 12" on center
 2. Interior or exterior (gasket cut 2" from top rail and bottom rail on stile).

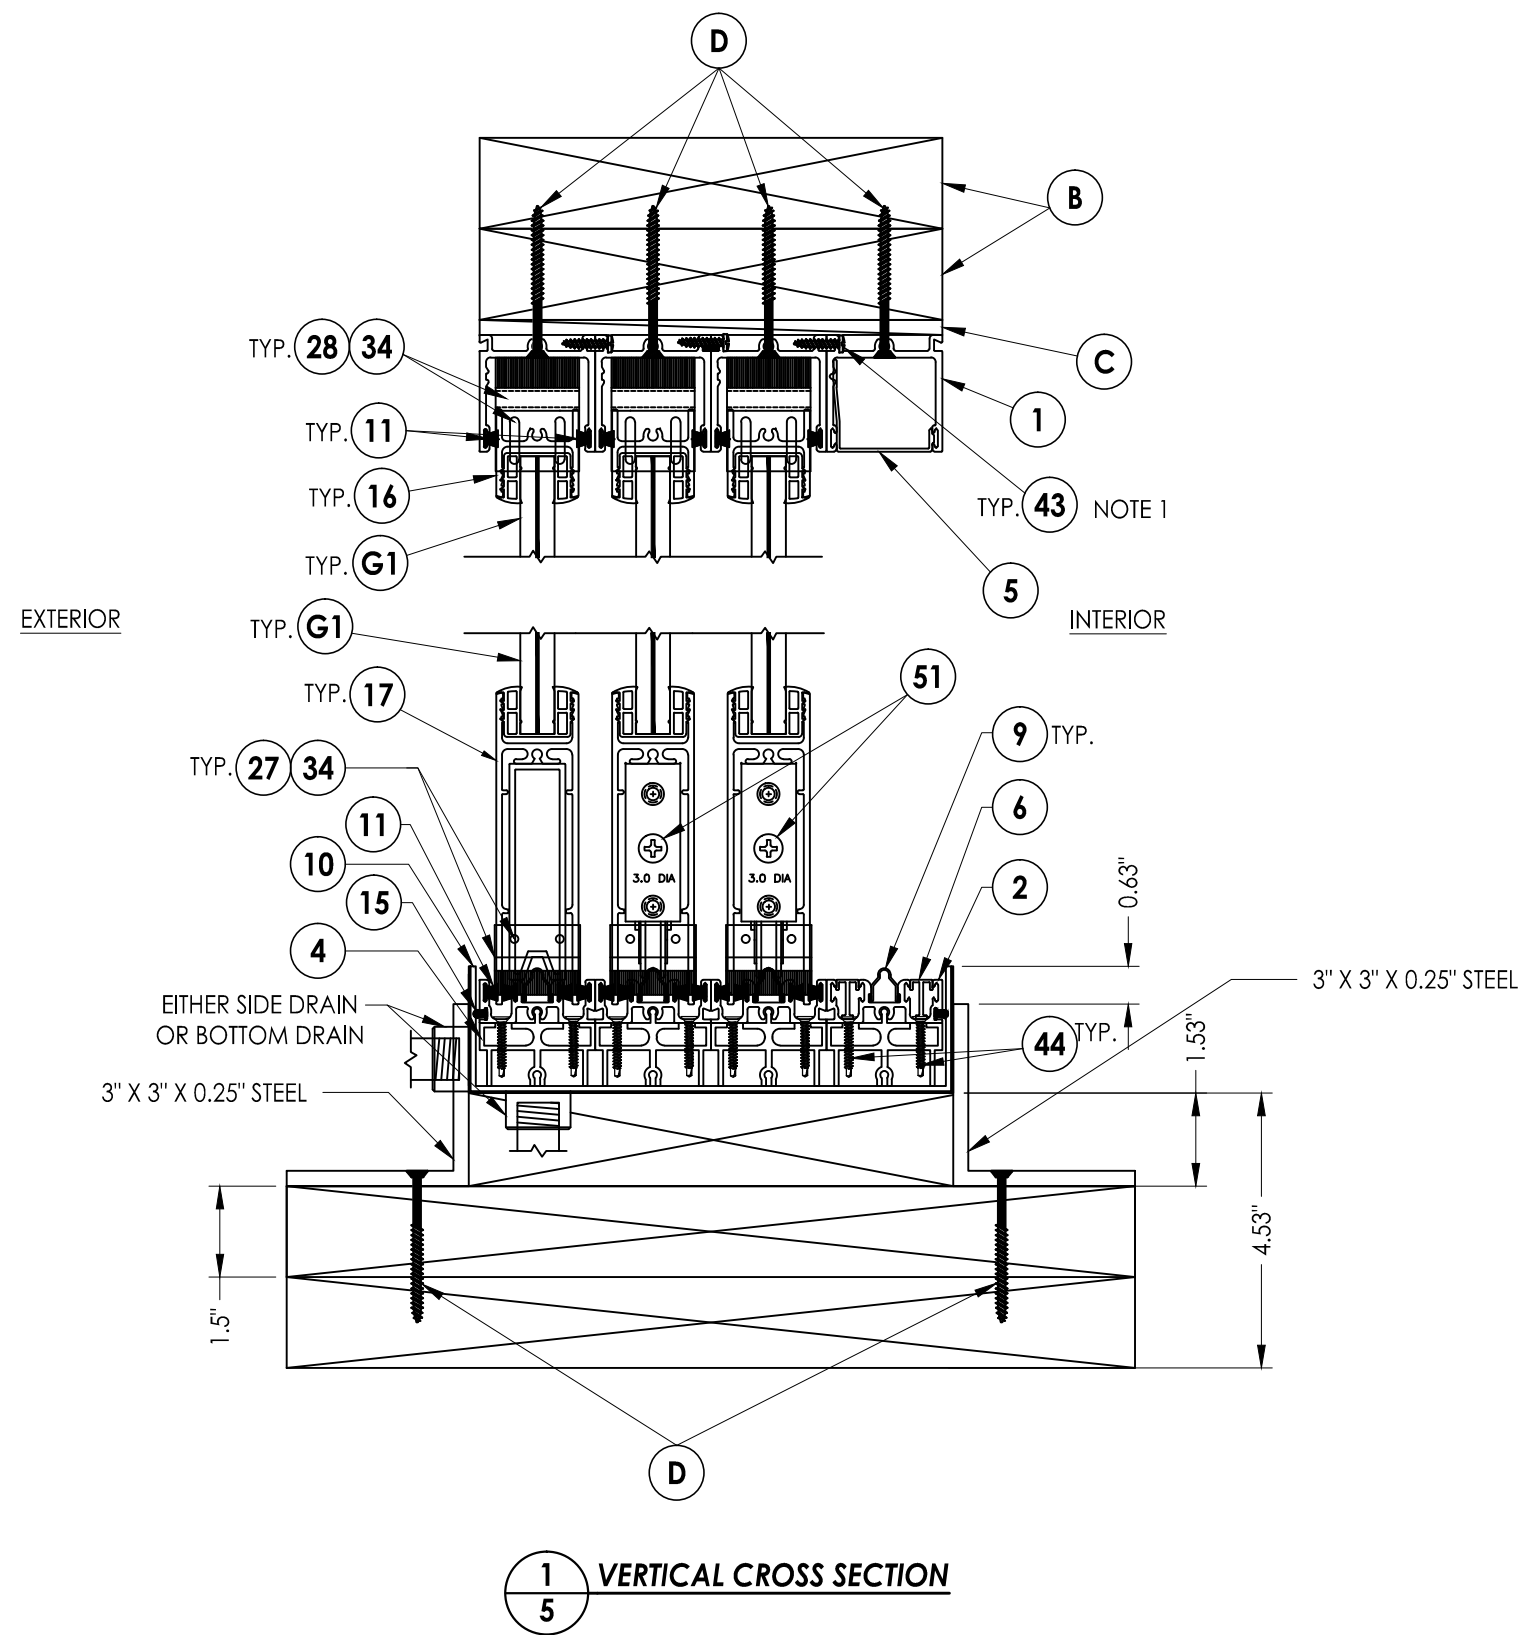
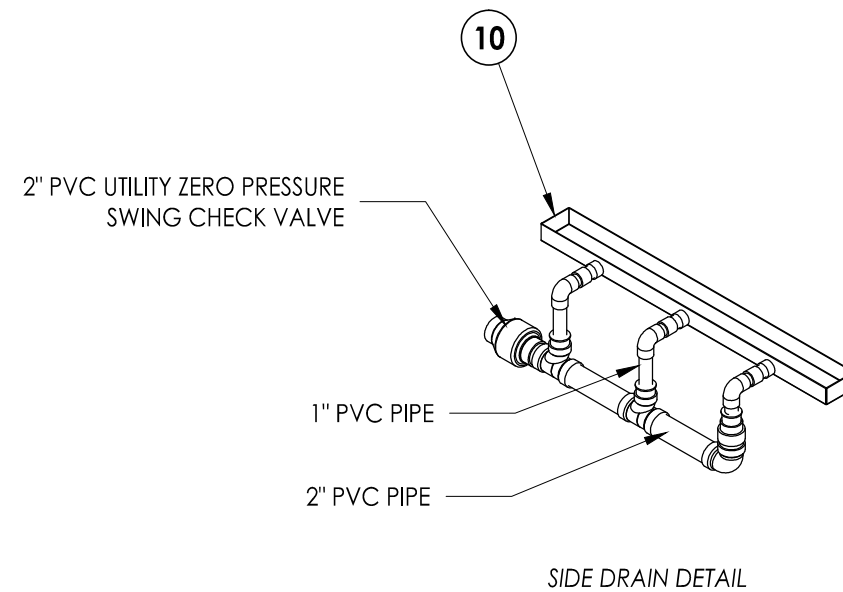
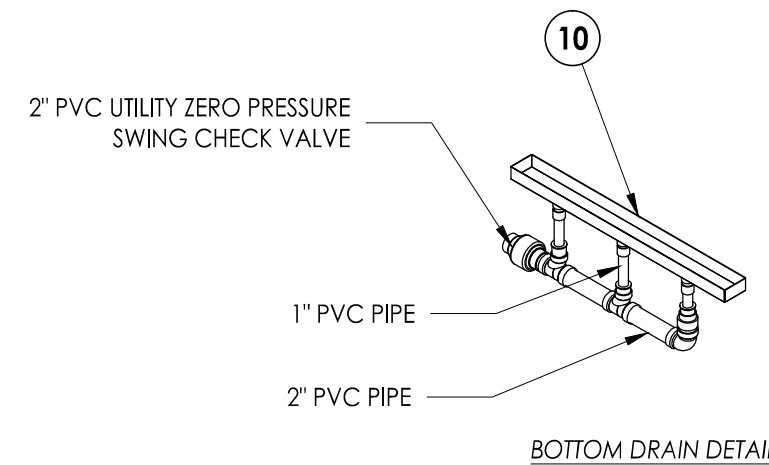
NOTE:
 1. 1" from each end then 60" on center.
