MIAMI-DADE COUNTY PERFORMANCE TEST REPORT

Report No.: E8391.03-301-18

FLEETWOOD WINDOWS AND DOORS
Corona, California

PRODUCT TYPE: Sliding Door
SERIES/MODEL: 3070-HI

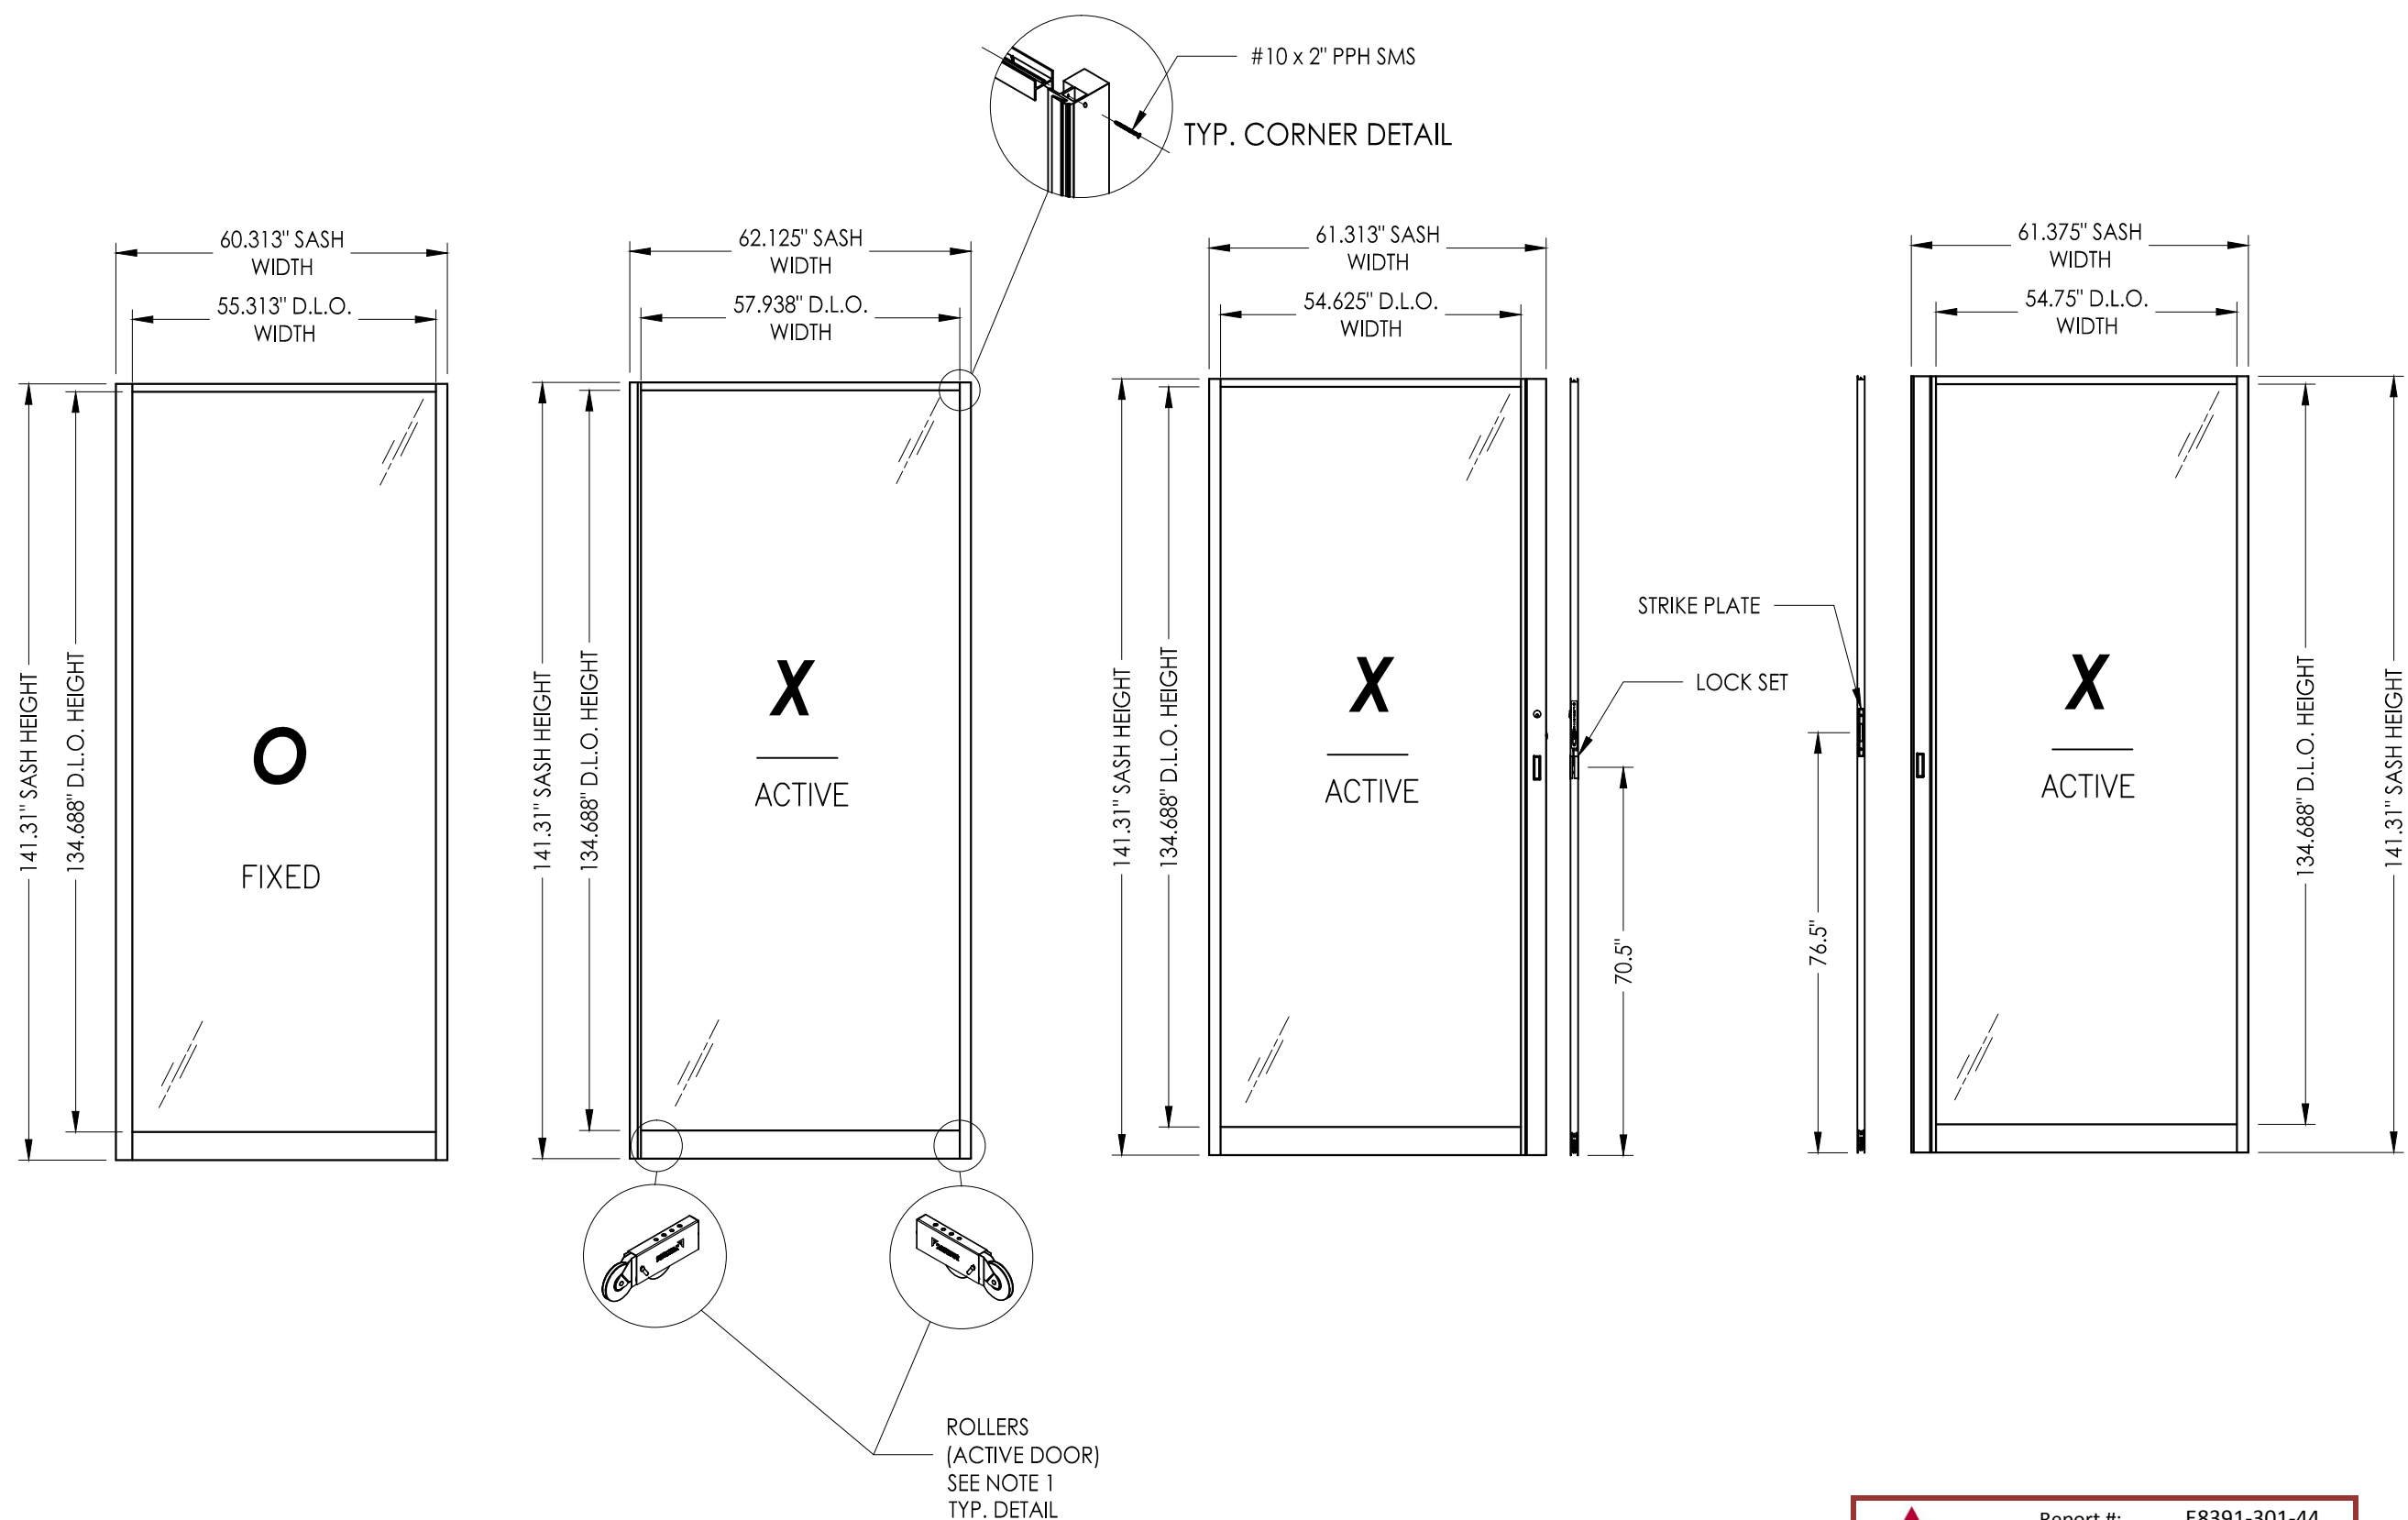
Note:
 1. Roller attached to bottom rail utilizing (2) 1/4-20 x 1/2" PFH Screw and attached to Stile utilizing (2) 1/4 -20 x 1" PPH Screw.
